## EXPERIMENTAL EVALUATION OF THE STRUCTURAL BEHAVIOUR OF ADOBE MASONRY STRUCTURAL ELEMENTS

### ABSTRACT

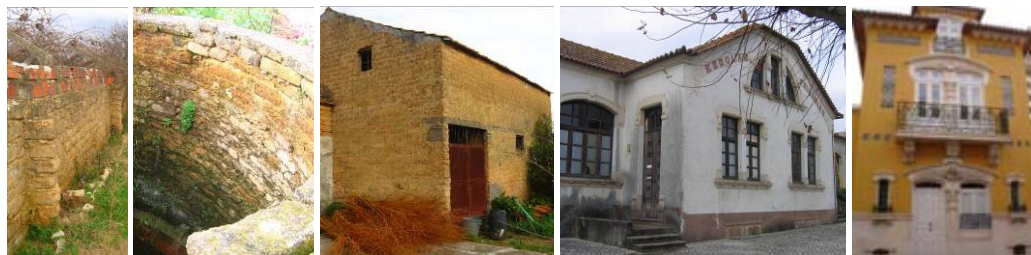
**Figure 1.** Examples of existing adobe constructions in Aveiro district.

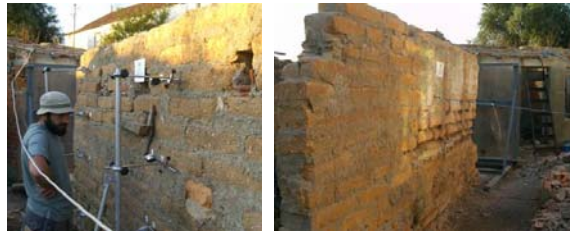
**Figure 7.** *In situ* out-of-plane testing layout: wall; horizontal displacement transducers; and horizontal loading system.

In a second phase, adopting a different testing setup (Fig. 7), out-of-plane horizontal forces were applied to the wall, in cycles of increasing amplitude, but without inversion of the force signal, till the collapse was reached (Fig. 8).
